New Hampshire Volunteer Lake Assessment Program

2003 Biennial Report for Reservoir Pond Lyme

NHDES
Water Division
Watershed Management Bureau
29 Hazen Drive
Concord, NH 03301

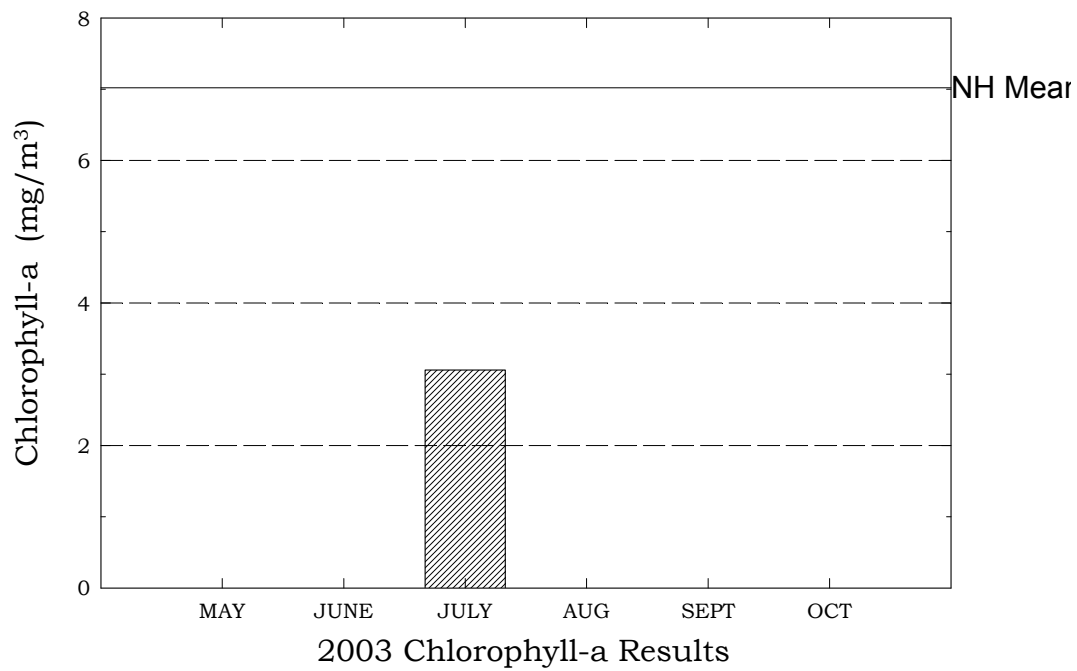
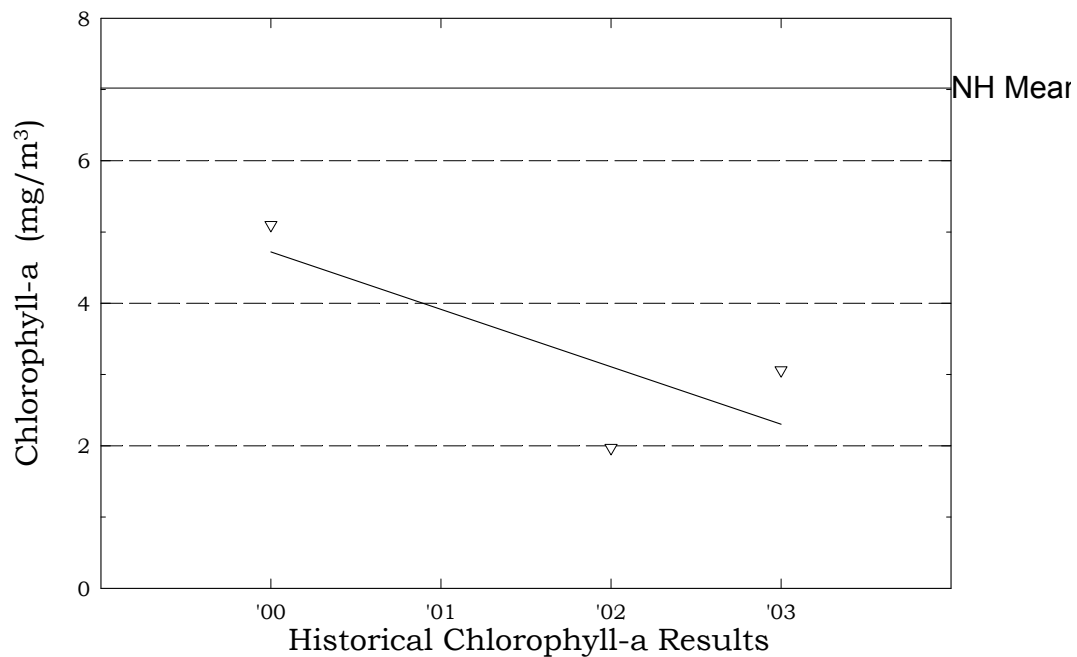
Figure 1. Monthly and Historical Chlorophyll-a Results

- **Figure 1 and Table 1:** The graphs in Figure 1 (Appendix A) show the historical and current year chlorophyll-a concentration in the water column. Table 1 (Appendix B) lists the maximum, minimum, and mean concentration for each sampling season that the pond has been monitored through the program.

The current year data (the top graph) show that the chlorophyll-a concentration in July was **less than** the state mean.

Overall, visual inspection of the historical data trend line (the bottom graph) shows **a decreasing** in-lake chlorophyll-a trend, meaning that the concentration has **improved** since monitoring began. However, this is based on limited data. After 10 consecutive years of sample collection, we will be able to conduct a statistical analysis of the historic data to objectively determine if there has been a significant change in the annual mean chlorophyll-a concentration since monitoring began.

While algae are naturally present in all lakes/ponds, an excessive or increasing amount of any type is not welcomed. In freshwater lakes/ponds, phosphorus is the nutrient that algae depend upon for growth. Algal concentrations may increase with an increase in nonpoint sources of phosphorus loading from the watershed, or in-lake sources of phosphorus loading (such as phosphorus releases from the sediments). Therefore, it is extremely important for volunteer monitors to continually educate residents about how activities within the watershed can affect phosphorus loading and pond quality.

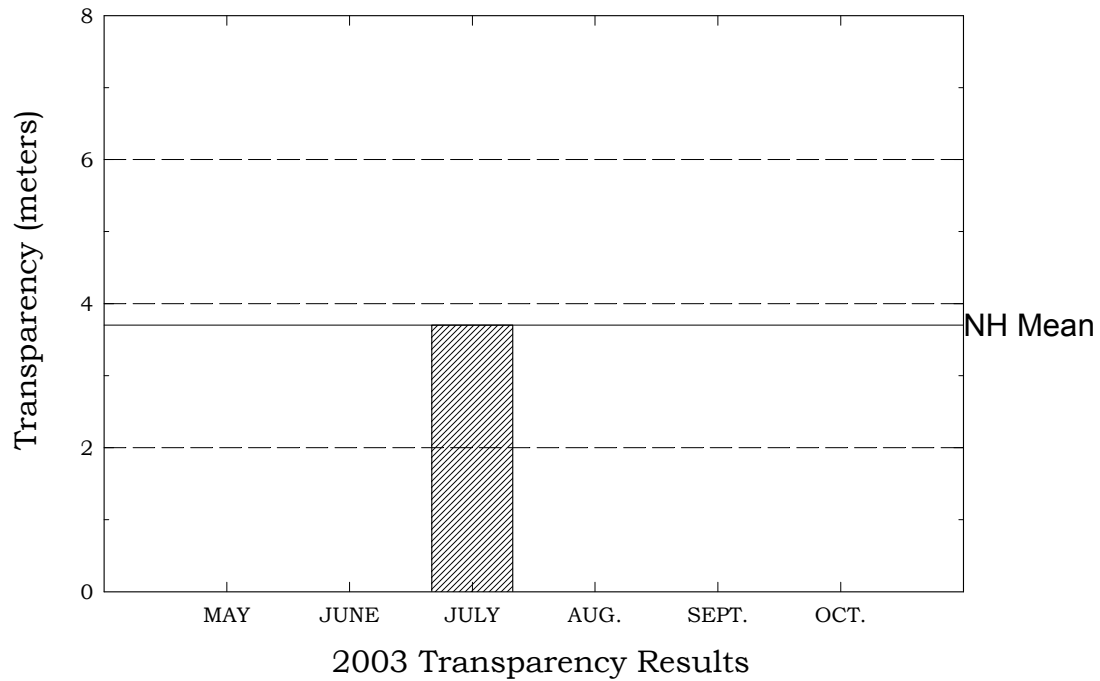
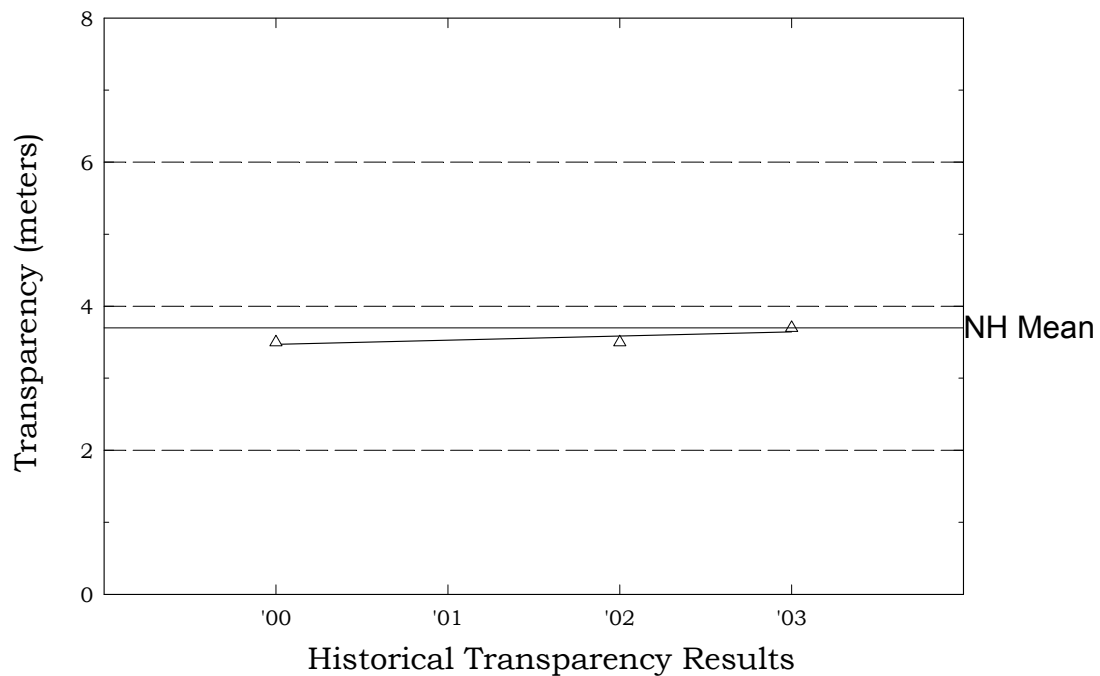
Figure 2. Monthly and Historical Transparency Results

- **Figure 2 and Table 3:** The graphs in Figure 2 (Appendix A) show historical and current year data for pond transparency. Table 3 (Appendix B) lists the maximum, minimum and mean transparency data for each sampling season that the pond has been monitored through the program.

The current year data (the top graph) show that the in-lake transparency in July was **approximately equal to** the state mean.

Overall, visual inspection of the historical data trend line (the bottom graph) shows **a stable** trend for in-lake transparency, meaning that the transparency has **remained approximately the same** since monitoring began. However, this is based on limited data. After 10

Typically, high intensity rainfall causes erosion of sediments into lakes/ponds and streams, thus decreasing clarity. Efforts should continually be made to stabilize stream banks, pond shorelines, disturbed soils within the watershed, and especially dirt roads located immediately adjacent to the edge of tributaries and the pond. Guides to Best Management Practices designed to reduce, and possibly even eliminate, nonpoint source pollutants, such as sediment loading, are available from DES upon request.

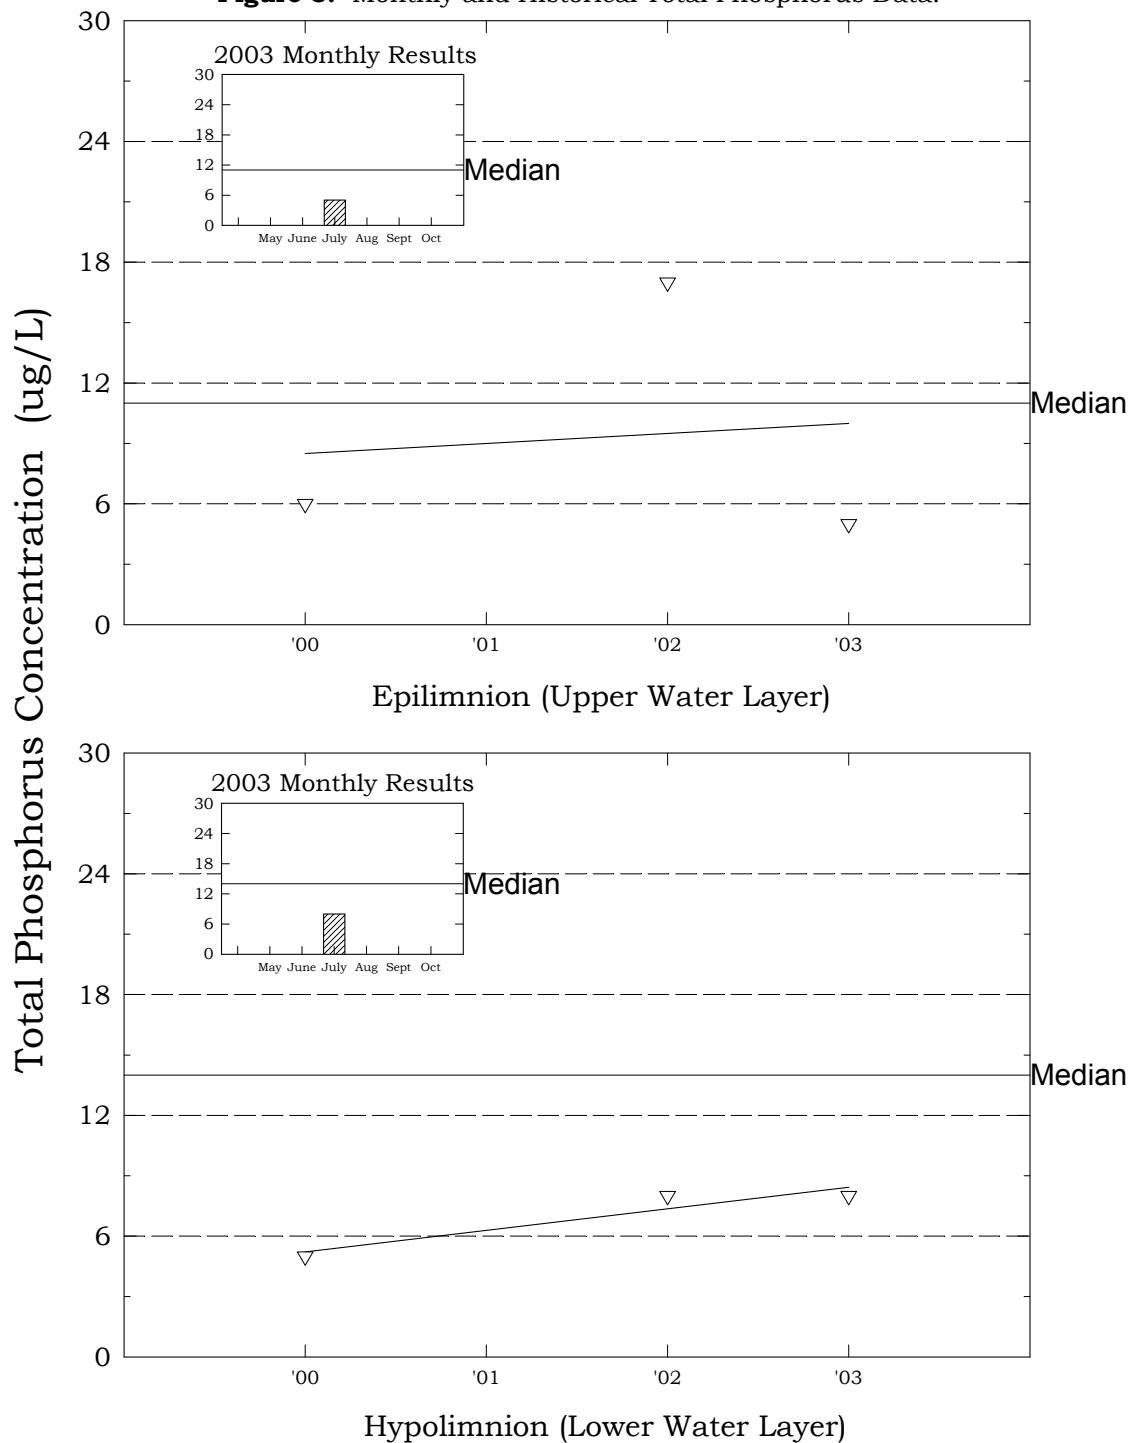
Figure 3. Monthly and Historical Total Phosphorus Data.

- **Figure 3 and Table 8:** The graphs in Figure 3 (Appendix A) show the amounts of phosphorus in the epilimnion (the upper layer) and the hypolimnion (the lower layer); the inset graphs show current year data. Table 8 (Appendix B) lists the annual maximum, minimum, and median concentration for each deep spot layer and each tributary since the pond has joined the program.

The current year data for the epilimnion (the top inset graph) and the hypolimnion (the bottom inset graph) show that the phosphorus concentration in July was **less than** the state median.

Overall, visual inspection of the historical data trend line for the epilimnion shows a **variable** phosphorus trend, which means that the concentration has **fluctuated** in the epilimnion since monitoring began.

Overall, visual inspection of the historical data trend line for the hypolimnion shows **an increasing** phosphorus trend, which means that the concentration has **worsened** in the hypolimnion since monitoring began.

One of the most important approaches to reducing phosphorus loading to a waterbody is to continually educate watershed residents about its sources and how excessive amounts can adversely impact the ecology and value of lakes and ponds. Phosphorus sources within a lake or pond's watershed typically include septic systems, animal waste, lawn fertilizer, road and construction erosion, and natural wetlands.
